# Extrication Challenges Of Advanced Steel in Vehicles – Part 1

- SUBJECT:** Advanced Steel
- TOPIC:** Extrication Challenges of Advanced Steel in Vehicles, Part 1
- OBJECTIVE:** Review the cutting capabilities of vehicle rescue tools including hand tools, electric cutters, air-powered cutters and hydraulic rescue system cutting tools.
- TASK:** Given the information contained in Part 1 of this series, the rescuers will be able to assess the capabilities of the cutting tools carried by their department for vehicle rescue work that involves vehicles built with reinforced A-pillars, B-pillars and roof rail structures.

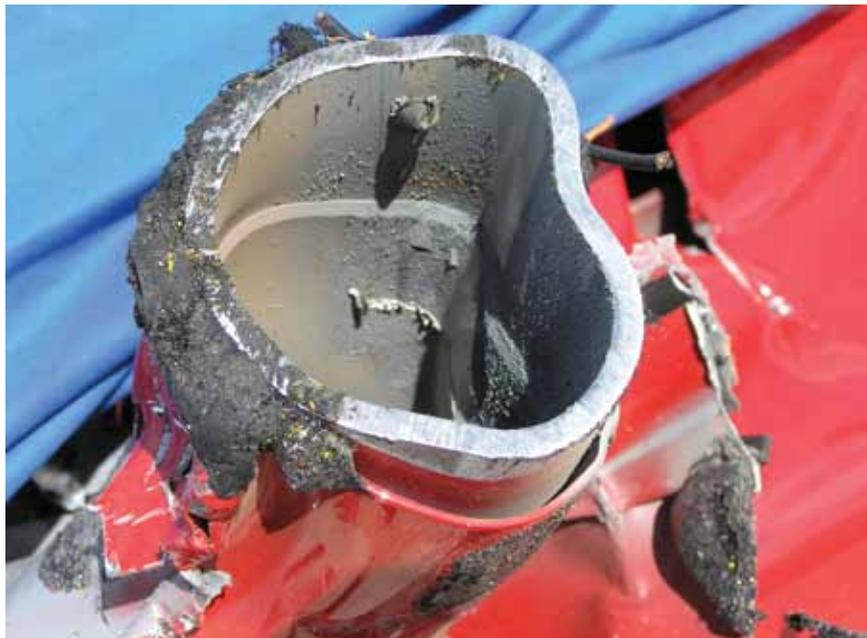
This image shows a cross section of the A-pillar of a Volvo C-70 automobile. The pillar metal is just shy of being quarter-inch-thick steel. Up until now, the typical automobile A-pillar that we encounter is approximately only one-16th-inch-thick steel.

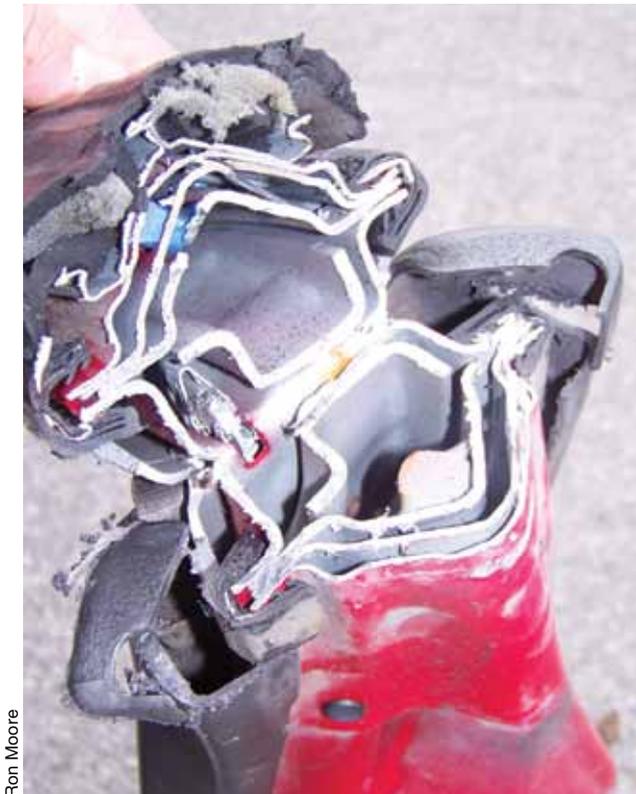
This B-pillar from a Subaru Impreza vehicle has been sliced open to expose the inner layers of steel and the steel rebar welded inside. A power cutter would have to cut through at least six layers of steel plus the solid rebar if it were to be successful.

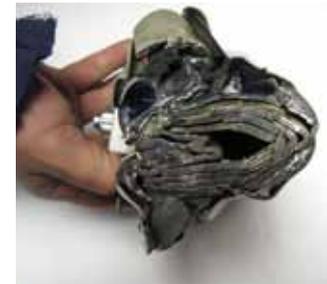
The 2008 Camry B-pillar crushed under the power of the hydraulic rescue cutters being used by the Rockville, MD, volunteer firefighters but did not cut through. Depending upon where you count, the cutters stalled out while trying to sever eight or as many as 14 layers of steel in the pillar. Later, a rotary saw with an abrasive blade cut the pillar.

In Maryland, firefighters from Rockville Volunteer Fire Department arrived at a serious collision involving a 2008 Toyota Camry. The vehicle was struck on the driver's side, trapping the female driver. The Toyota B-pillar, when compressed or squeezed by the blades of a hydraulic power cutter, resembled a folded wallet. The rescue team's hydraulic tools were unable to cut through the B-pillar at this extrication scene.
