Extrication Challenges Of Advanced Steel in Vehicles – Part 1

- SUBJECT:** Advanced Steel
- TOPIC:** Extrication Challenges of Advanced Steel in Vehicles, Part 1
- OBJECTIVE:** Review the cutting capabilities of vehicle rescue tools including hand tools, electric cutters, air-powered cutters and hydraulic rescue system cutting tools.
- TASK:** Given the information contained in Part 1 of this series, the rescuers will be able to assess the capabilities of the cutting tools carried by their department for vehicle rescue work that involves vehicles built with reinforced A-pillars, B-pillars and roof rail structures.

Extrication Challenges Of Advanced Steel in Vehicles: Part 2 - Advanced Steel

Extrication Challenges of Advanced Steel In Vehicles: Part 3 – Cutting Tools

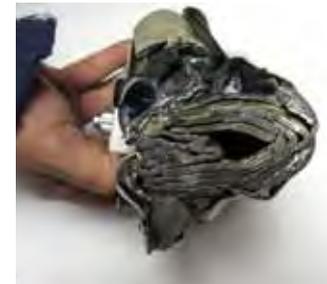
The 2008 Camry B-pillar crushed under the power of the hydraulic rescue cutters being used by the Rockville, MD, volunteer firefighters but did not cut through. Depending upon where you count, the cutters stalled out while trying to sever eight or as many as 14 layers of steel in the pillar. Later, a rotary saw with an abrasive blade cut the pillar.

In Maryland, firefighters from Rockville Volunteer Fire Department arrived at a serious collision involving a 2008 Toyota Camry. The vehicle was struck on the driver's side, trapping the female driver. The Toyota B-pillar, when compressed or squeezed by the blades of a hydraulic power cutter, resembled a folded wallet. The rescue team's hydraulic tools were unable to cut through the B-pillar at this extrication scene.

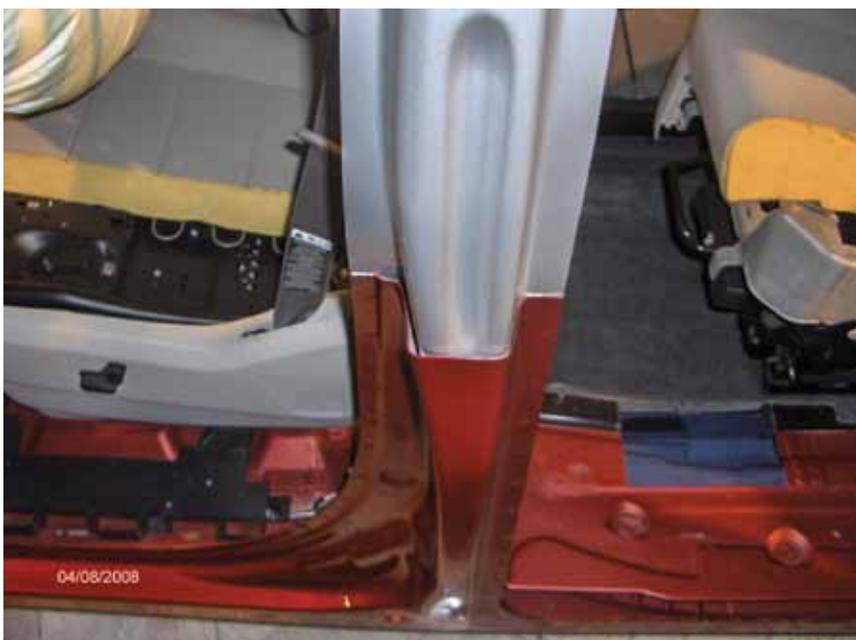
The cut-away view of the B-pillar in this demonstration vehicle reveals that the B-pillar is not entirely Boron steel. Only the silver-colored inner layer of steel shown here is Boron. In most cases, only one layer of two or three layers will be advanced steel. In the real-world, there is no visible difference between the appearance of normal mild steel and any of the advanced steels on a vehicle.

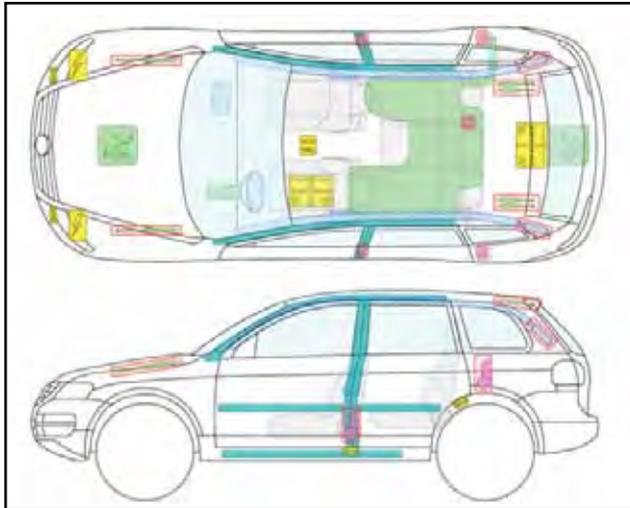
This screen shot from Moditech Rescue Solutions' Crash Recovery System reveals locations where advanced steel is used on a late-model Volkswagen Touareg vehicle. The greenish areas show Boron steel in the roof rail, A- and B-pillars, rocker and door collision beams.

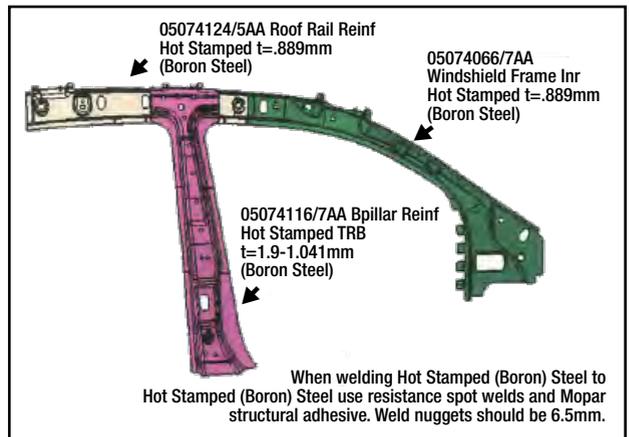
This schematic diagram of the Boron structure of a new Jeep Compass SUV reveals not only where the Boron is located on this vehicle but even the engineered thicknesses at various points. Note that the Boron varies from less than a millimeter in thickness to almost two millimeters thick. For reference, a U.S. quarter is not quite two millimeters in thickness.

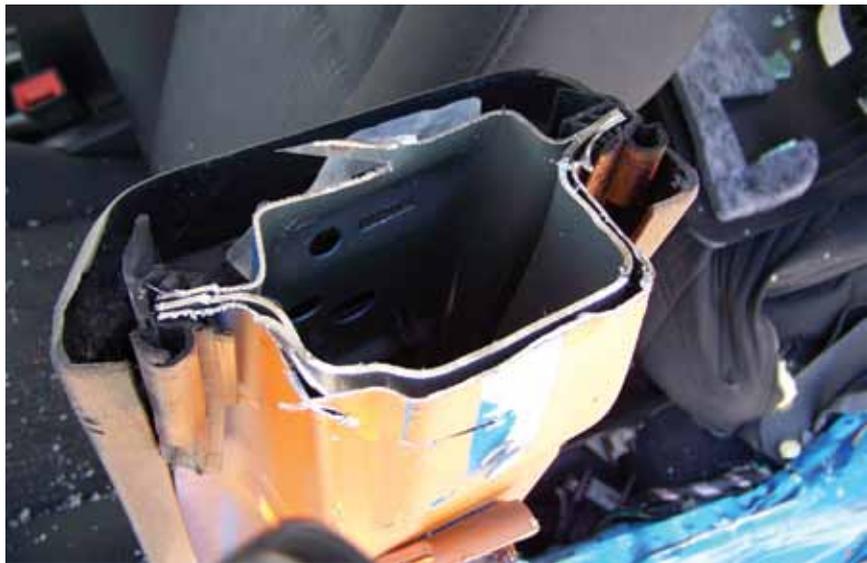
This cross-section of the B-pillar on the driver's side of a Dodge Caliber reveals the multiple layers that make up the pillar. The outer layer and the inner-most layer are mild steel. Only the thicker middle layer is advanced steel; in this case, hot-stamped Boron.

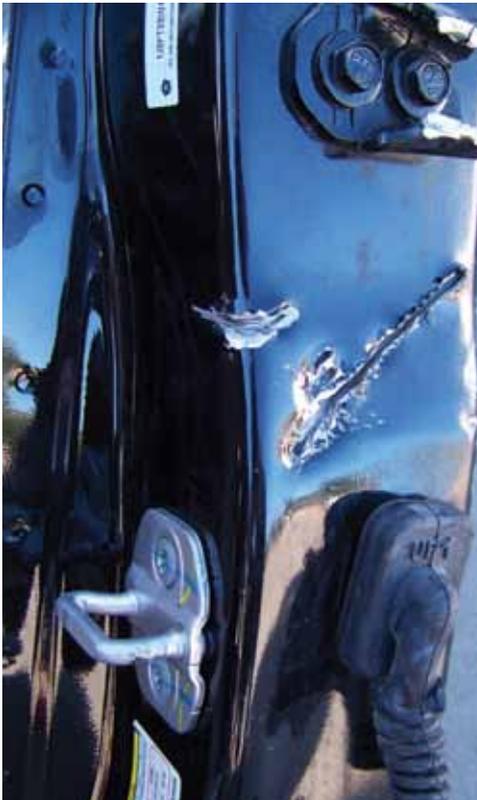
After repeated unsuccessful attempts to cut into or through a Boron B-pillar with various air chisels, the tests were stopped. The chisel was only able to cut into the outer mild steel layer and would not cut through the inner Boron.

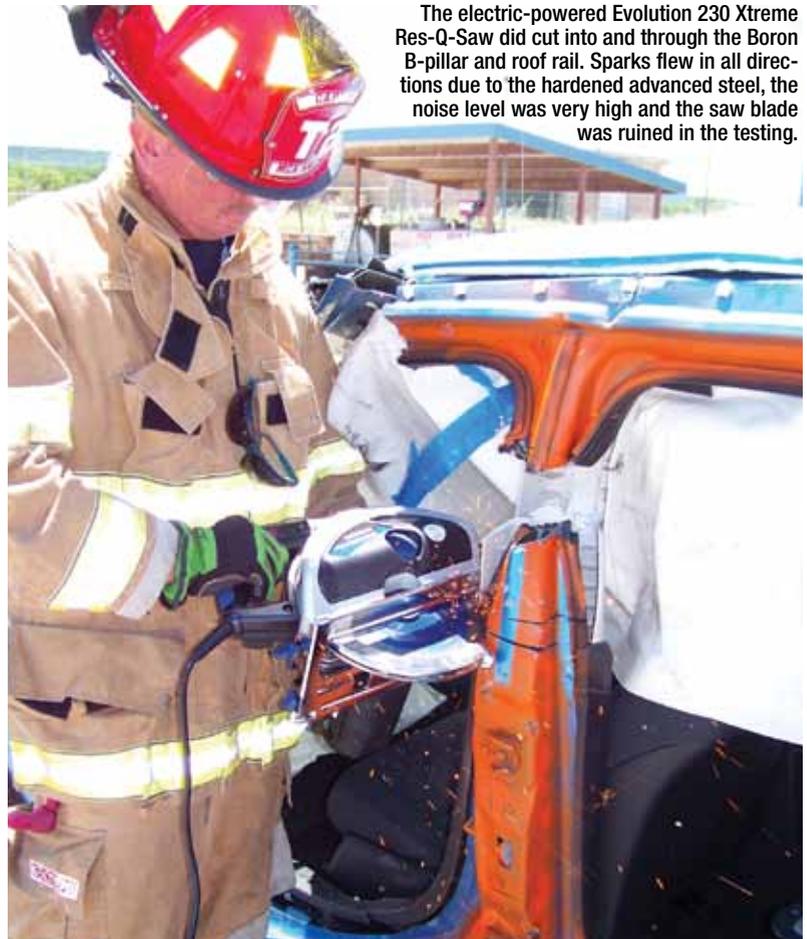
The electric-powered Evolution 230 Xtreme Res-Q-Saw did cut into and through the Boron B-pillar and roof rail. Sparks flew in all directions due to the hardened advanced steel, the noise level was very high and the saw blade was ruined in the testing.

Next, the Evolution 230 Xtreme Res-Q-Saw from the Res-Q-Jack Co. was offered for evaluation. This new tool for vehicle rescue is an electric-powered circular saw that utilizes a 1,750-watt, 15-amp motor to power a nine-inch-diameter carbide-tipped blade. The blade is specifically designed to cut mild steel, aluminum, stainless steel and wood. The saw did cut completely through the thickest 1.9-mm portion of a Boron B-pillar on a Dodge Caliber, but only after much effort on the part of the rescuers handling the saw.

Because the teeth on the saw blade were up against a hardened metal, there was a significant shower of sparks coming off the blade in all directions and damage occurred to the blade itself. Of the 48 carbide tips on the blade when we started, approximately 10 were gone by the time we completed our B-pillar cut. The noise level while the tool was working at maximum speed was almost deafening even while standing outside the vehicle. Yes, the saw cut through the 1.9-mm-thick layer of Boron steel in the B-pillar, but it isn't practical to consider this being realistically done at a real-world crash

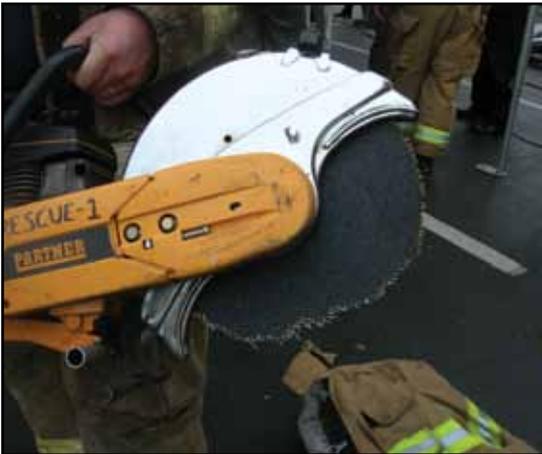
Cutting through the hardened advanced steel of the B-pillar destroyed the abrasive blade of the rotary saw. As expected, significant showers of sparks were generated during use of the saw, making this an unrealistic tool for extrication operations.

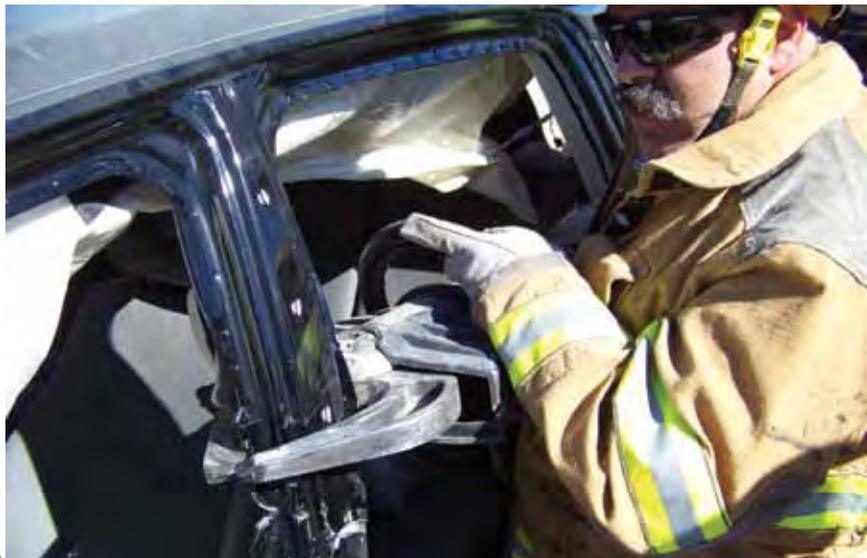
The most successful tool position for cutting through a Boron B-pillar was this "parallel" position. The blades were able to close more before cutting into the metal, letting them generate a greater force than if they were loaded while fully opened.

- The newer cutters that were able to cut through the Boron seemed to have larger cylinder bodies. They also were most successful when they severed the metal in one continuous motion, almost a shocking action. Advanced steels stress first, then fracture with a sound similar to that of breaking glass. Due to the larger cylinder body size, it takes more fluid to move the piston and force the blades closed on the new cutters. A problem could occur if a department upgraded to a new-generation cutter, but hooked it up to an older power plant with a small reservoir or a low-flow pump. The cutter would move slowly, take longer to build to maximum pressure and may seem to have poorer performance than the older cutter it is replacing. Operating new cutters through existing hose reels may further diminish the performance of the tool when attacking advanced steels.

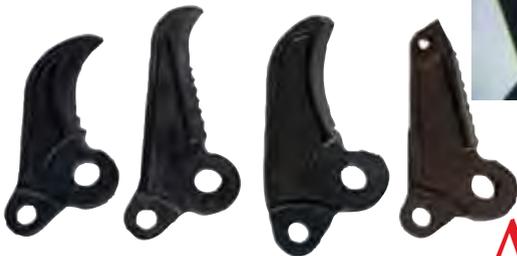
One of the lessons learned thus far is that blade design can be a significant factor in whether a power rescue tool cutter will be able to cut through advanced steel. Shown are examples of combination radius/serrated, elliptical, radius and serrated blades.

- Blade shape or design may be another significant factor as well. The Boron testing evaluated different blade designs; radius, elliptical, serrated and a combination radius/serrated unit. There were successes and failures with each style. Many times, the common radial blade design caused the tool to crush the multiple layers of metal into a tight bundle before it was able to try to cut the B-pillar. In some cases where the power of a tool was marginal, the crushing would occur and then the tool would stall out. In cases where serrations in the cutting edges of the blades allowed the pillar or roof rail to start tearing initially as the blades closed, the cutter may make it through the Boron.

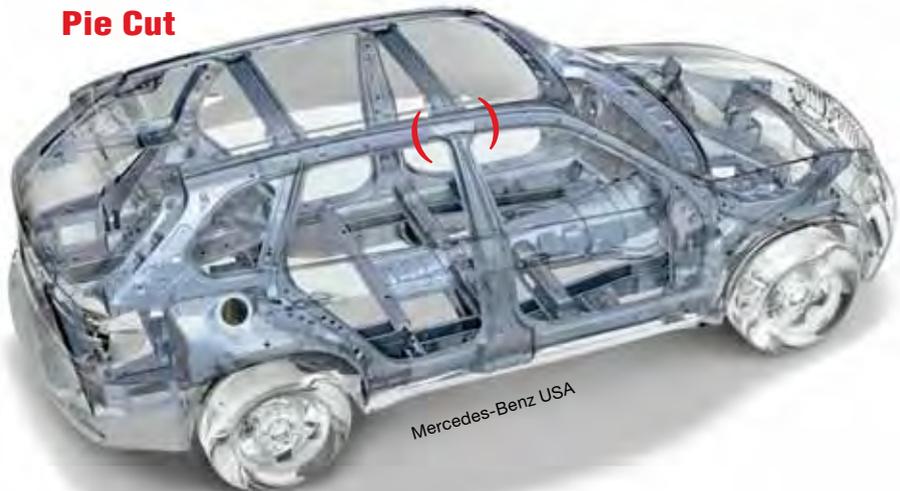
Pie Cut

If only the B-pillar contained advanced steel and not the roof rail, it might be possible to cut the roof rail on both sides of the top of the pillar in a "pie cut" fashion and lay the pillar down.

The fourth "work-around" assignment simulates that only the B-pillar contains advanced steel and not the roof rail. This design is used in late-model vehicles from Toyota Motors. For this task, the assigned team disregards the fact that the roof rail has been painted. The simulation is that it is possible to cut the roof rail on both sides of

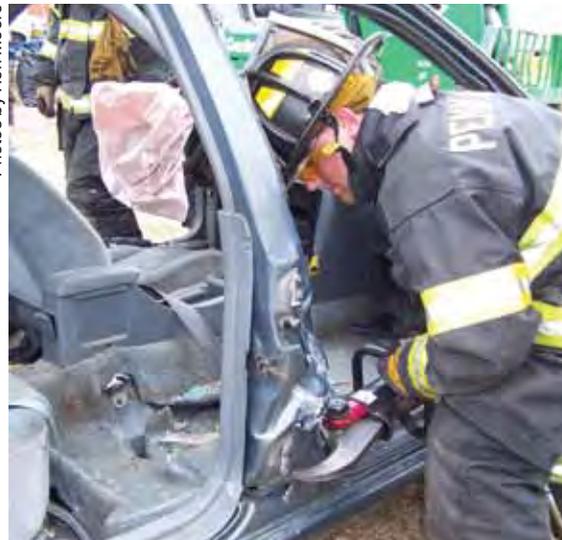
Lifting the B-Pillar (1)

With this training exercise, we are simulating that most of the B-pillar and all of the roof rail consists of advanced steel that the rescue team cannot cut through. Rescuers should be trained to attempt to cut all along the roof rail, just in case there is "soft" steel somewhere within the structure. Here, efforts to cut through the pillar near the rocker channel are successful. One popular Chrysler vehicle's structural design has mild steel at the bottom of the B-pillar, spot welded to the main portion of the pillar.

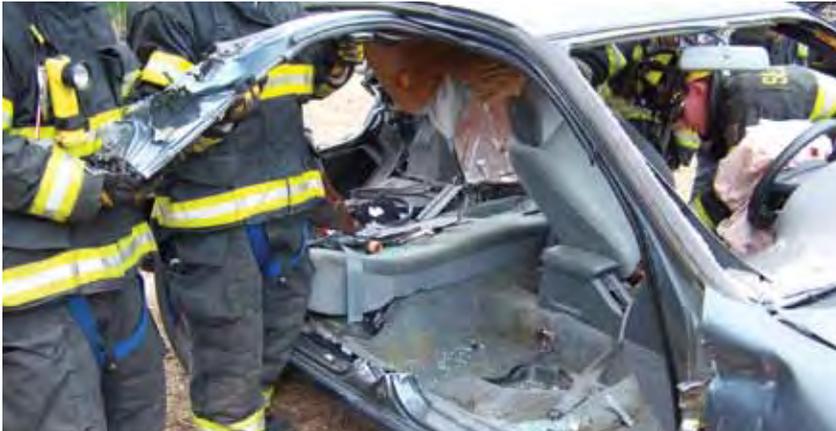
Lifting the B-Pillar (2)

Once the B-pillar is cut through at the bottom, it can be lifted up and away from the simulated trapped patient. The patient doesn't care if you lay the B-pillar down or lift the B-pillar up; they just want out.

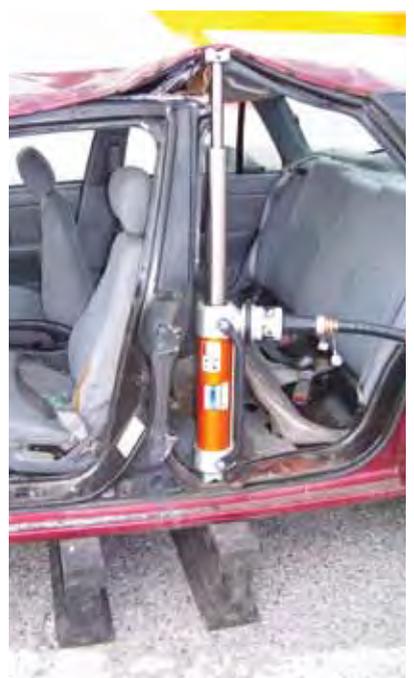
Ram the Roof Off

When a rescue team cannot cut through a B-pillar or roof rail that contains advanced steel, a backup plan can be to ram the roof off the top of the B-pillar. Even though advanced steel may be present, a powerful ram may be able to push the roof rail up until it begins to tear at the spot welds.

When a rescue team cannot cut through a B-pillar or roof rail that contains advanced steel, a good “work-around” technique can be to ram the roof off the top of the B-pillar. Even though advanced steel may be present, a powerful ram may be able to push the roof rail up until it begins to tear free at the spot welds.

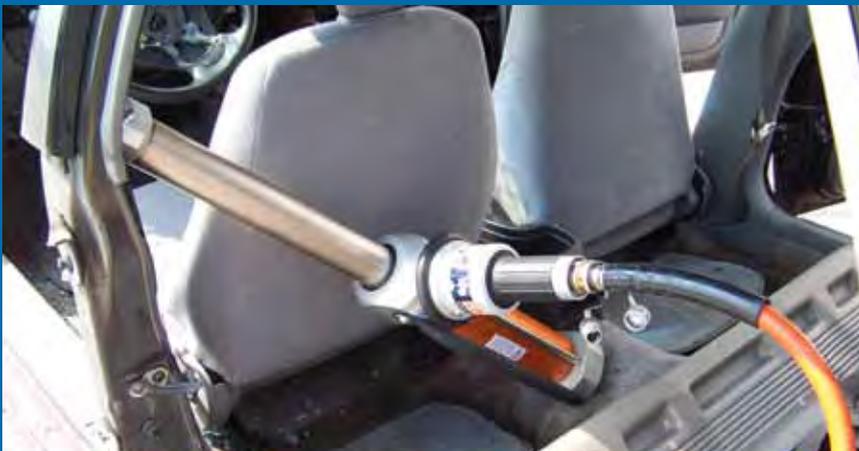
Spreading the B-Pillar

If an advanced steel B-pillar cannot be cut through, an alternative can be to ram the B-pillar away from the trapped occupants. Here, a push off the center "tunnel" moves the pillar.

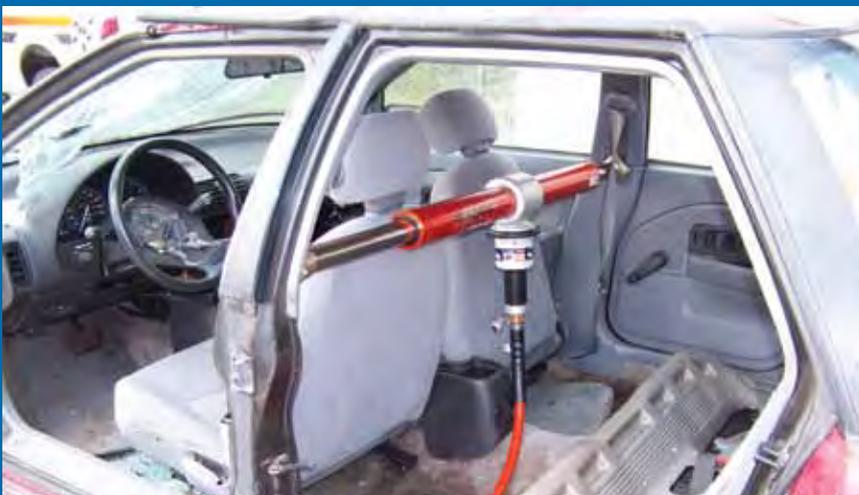
A spread from B-pillar to B-pillar can also be used to move a crash-damaged pillar off of the patients trapped inside. Monitor roof movement as it may begin to lower into the vehicle as the B-pillars move outward.

Begin on the driver's side and assign a team to slightly widen the B-pillars as if one had been crushed inward due to a severe side impact. This crew must spread with a tool such as a power ram from B-pillar to B-pillar to simulate moving a crash-damaged pillar off of a driver trapped inside. It is not an easy task because the seatbacks will obstruct this spreading effort and many teams have power rams but they may not ex-

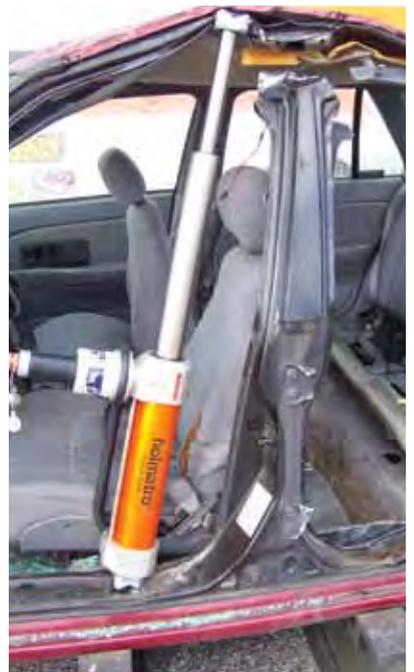
After an initial push behind the B-pillar, a second push along the front side may be enough to completely tear the B-pillar from the roof rail. Note that cribbing will be necessary beneath the rocker to support the push of the ram.

The assigned team must place additional cribbing beneath the rocker to support the force of the ram. After an initial push on one side of the B-pillar, a second push on the opposite side may be enough to completely tear the B-pillar away from the roof rail in a real-world situation. Once separated from the roof, the crew must practice bending the pillar down without making any additional cuts. It simulates not being able to cut the bottom of the pillar in a real-world scenario.

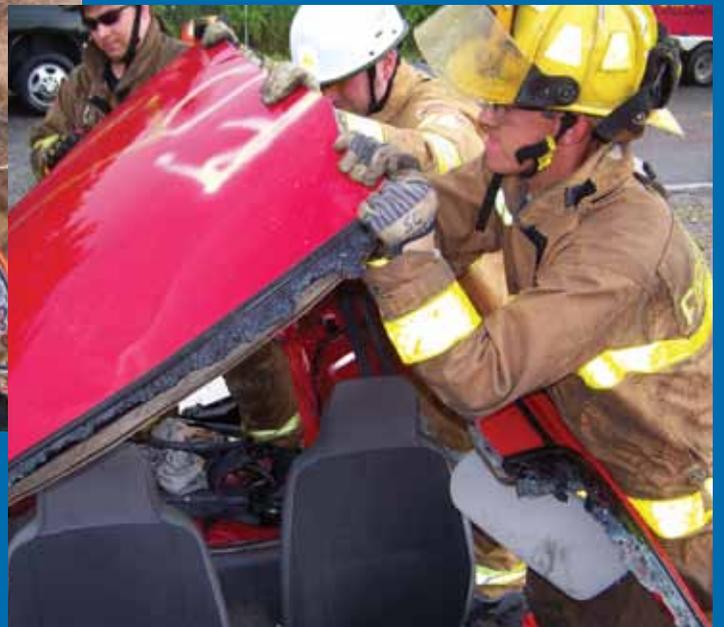
Total Sunroof

A relief cut is made at the front and rear on the "hinge" side of the roof and the entire roof panel is lifted up and away from your trapped patient. A rapid extrication could be accomplished once the "total sunroof" is open.

When a team encounters a vehicle with all roof pillars, the entire roof rail and the entire rocker channel containing advanced steel, an optional technique can be the "total sunroof" evolution. First, the roof is cut from the front windshield header to the rear window. Here, a reciprocating saw is used.

With the "total sunroof" completed, if the side of the vehicle were still crushed in on your patient, you could push the sides away very easily now that the roof has essentially been disconnected from the side structure of the vehicle.

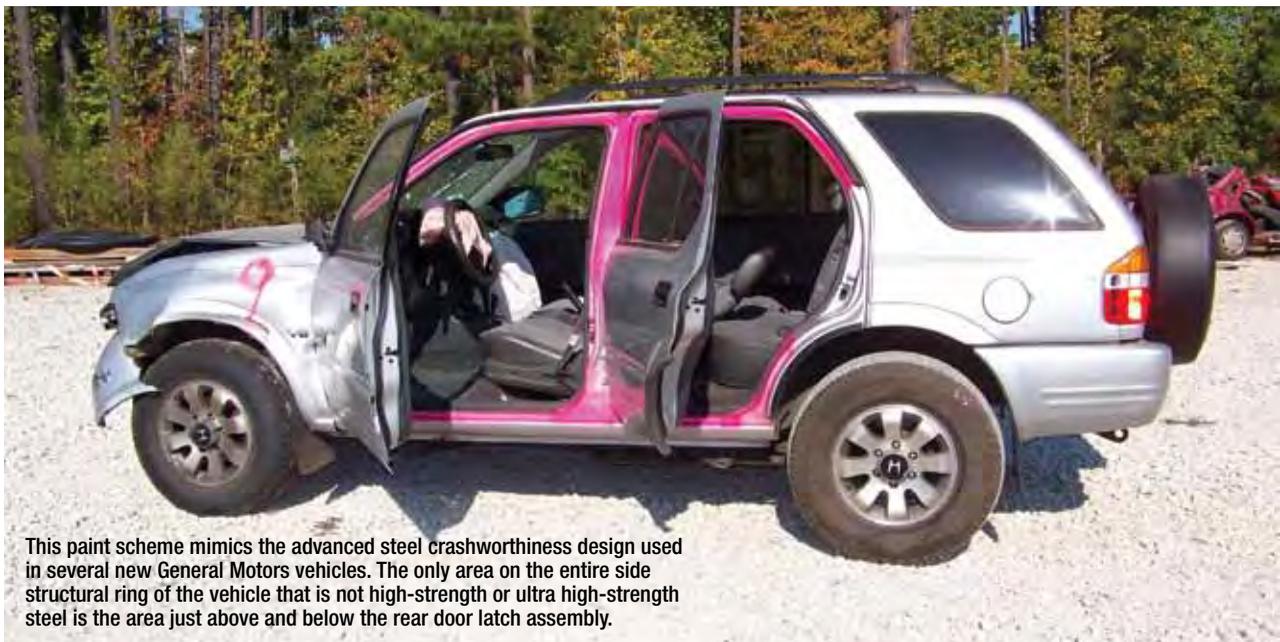
This paint scheme mimics the advanced steel crashworthiness design used in several new General Motors vehicles. The only area on the entire side structural ring of the vehicle that is not high-strength or ultra high-strength steel is the area just above and below the rear door latch assembly.

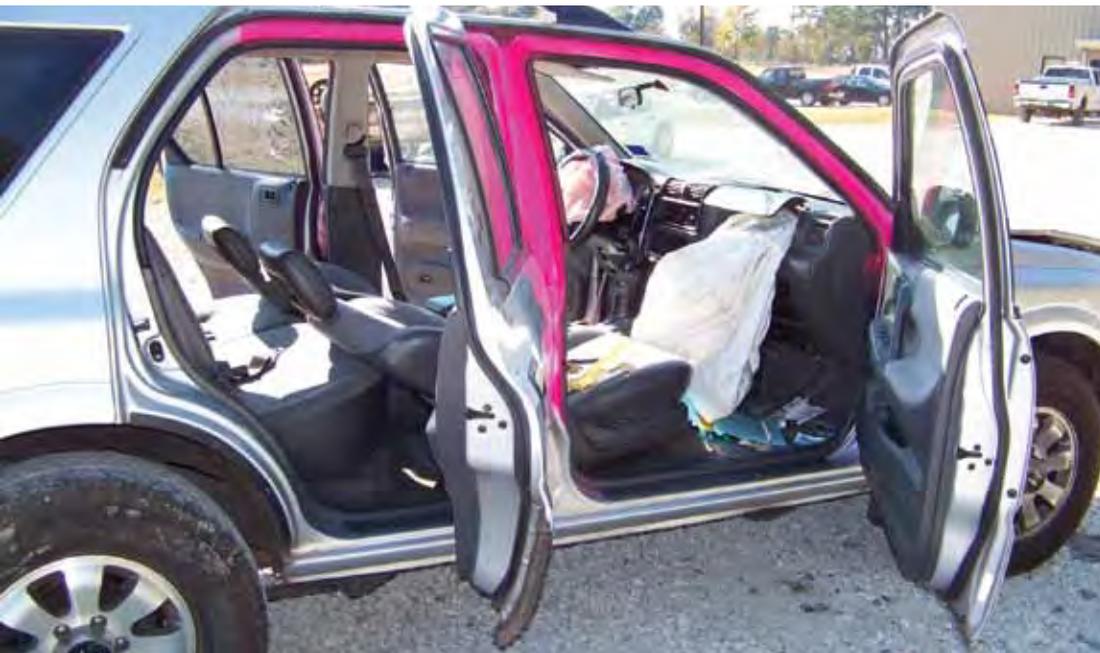
This paint scheme simulates advanced steel utilization in a late-model Chrysler Motors vehicle. The steel is inside the upper A-pillar, through a portion of the roofline, and inside most of the B-pillar.

Explain to your students that all painted edges of the structure on this car magically now contain advanced steel. Crews working on this car will simulate that they do not have a power rescue cutter tool that can get through this steel. They will have to accomplish "work-around" techniques that you will assign to them.

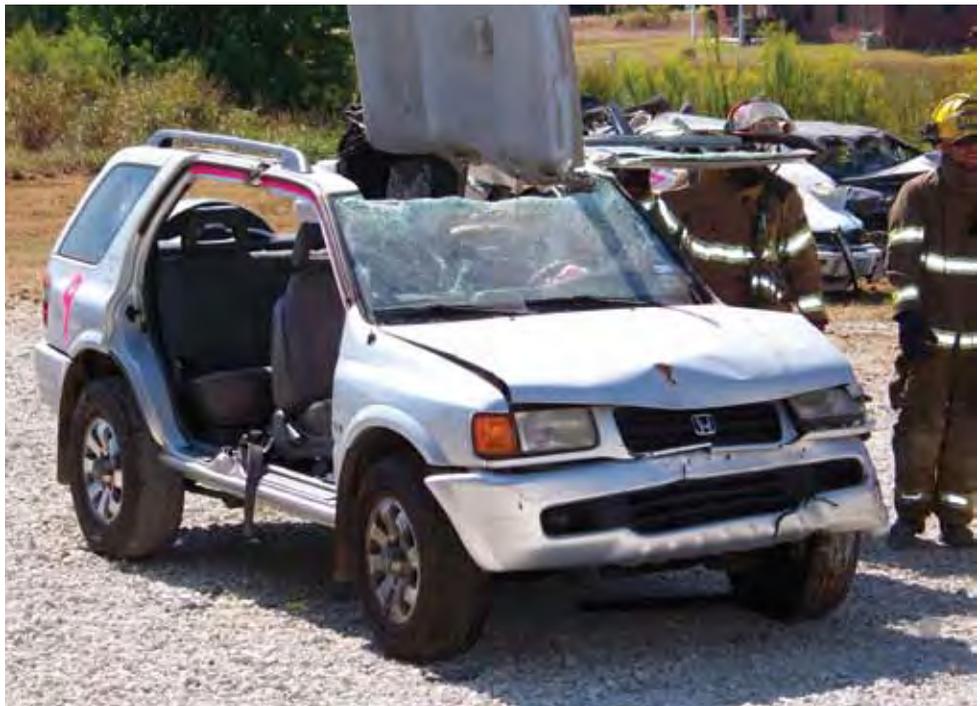
On this acquired vehicle, the crews have completed the total sunroof “work-around” assignment. For this task, only the top of the windshield needed to be cut to disconnect it from the roof. (Note: Restrictions imposed at the salvage yard required the crews to leave all tires inflated.)
