Extrication Challenges of Advanced Steel In Vehicles: Part 3 – Cutting Tools

- SUBJECT:** Advanced Steel
TOPIC: Extrication Challenges of Advanced Steel in Vehicles: Part 3
OBJECTIVE: The rescuer will understand and explain the capabilities and limitations of various manual-, air-, and electric-powered rescue tools.
TASK: Given the information contained in Part 3 of this series and reference to a late-model passenger vehicle, the rescuer will be able to identify individual rescue tools within the department's tool inventory that can and cannot be expected to cut through advanced steel Boron structural areas.

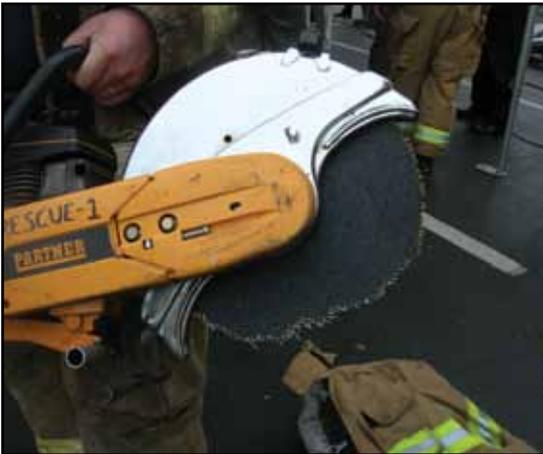
Cutting through the hardened advanced steel of the B-pillar destroyed the abrasive blade of the rotary saw. As expected, significant showers of sparks were generated during use of the saw, making this an unrealistic tool for extrication operations.

The final rescue tool in the saw category that was evaluated was a fire department gasoline-powered rotary saw. This versatile forcible entry tool was set up with an abrasive blade and tasked with cutting through the advanced steel structure of the vehicle. This saw, as one can already assume, did cut completely through the Boron B-pillar with only a typical amount of effort. That is the fact. The reality is that the blade was completely chewed up during the process, the

shower of hot sparks from the Boron steel were scattered throughout the length of the vehicle, and the noise and exhaust smoke also made this tool Boron-capable, but not Boron-realistic tool for a real-world rescue scene.
