Extrication Challenges of Advanced Steel In Vehicles: Part 4 – Power Cutters

SUBJECT: Advanced Steel
TOPIC: Extrication Challenges of Advanced Steel in Vehicles: Part 4
OBJECTIVE: The rescuer will understand and explain the capabilities and limitations of various hydraulic-powered rescue cutter tools
TASK: Given the information presented in Part 4 of this series, the rescuer will demonstrate the steps necessary to effectively operate a power cutter to cut through the advanced steel structural areas of a late-model passenger vehicle.

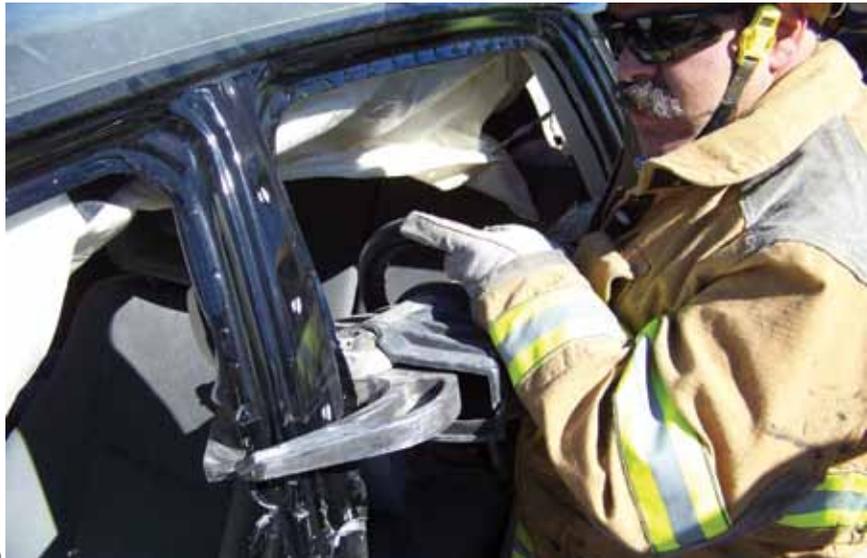
The most successful tool position for cutting through a Boron B-pillar was this "parallel" position. The blades were able to close more before cutting into the metal, letting them generate a greater force than if they were loaded while fully opened.

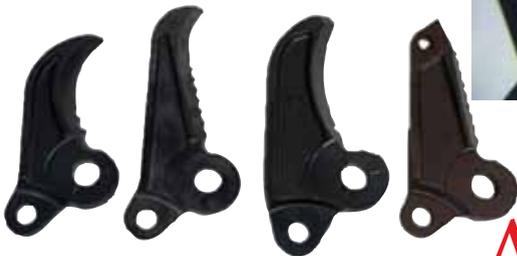
One of the lessons learned thus far is that blade design can be a significant factor in whether a power rescue tool cutter will be able to cut through advanced steel. Shown are examples of combination radius/serrated, elliptical, radius and serrated blades.

- Blade shape or design may be another significant factor as well. The Boron testing evaluated different blade designs; radius, elliptical, serrated and a combination radius/serrated unit. There were successes and failures with each style. Many times, the common radial blade design caused the tool to crush the multiple layers of metal into a tight bundle before it was able to try to cut the B-pillar. In some cases where the power of a tool was marginal, the crushing would occur and then the tool would stall out. In cases where serrations in the cutting edges of the blades allowed the pillar or roof rail to start tearing initially as the blades closed, the cutter may make it through the Boron.

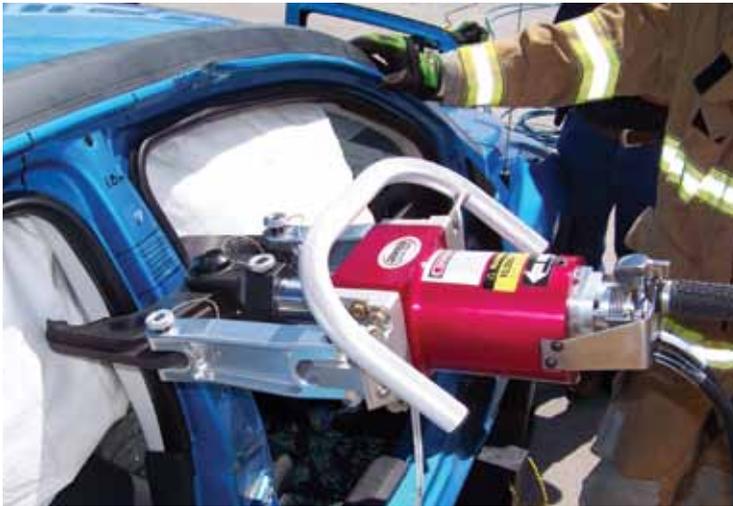
The Champion Beast with their USAR cutter blades is shown being tested on the B-pillar of a 2008 Dodge Caliber. This specific spot on our test vehicles contained the thickest 1.9mm Boron steel hidden inside the pillar.
